# **Dam Safety Assessment of CCW Impoundments**

## **Gallagher Generating Station**

**United States Environmental Protection Agency  
Washington, DC**

**April 7, 2011**

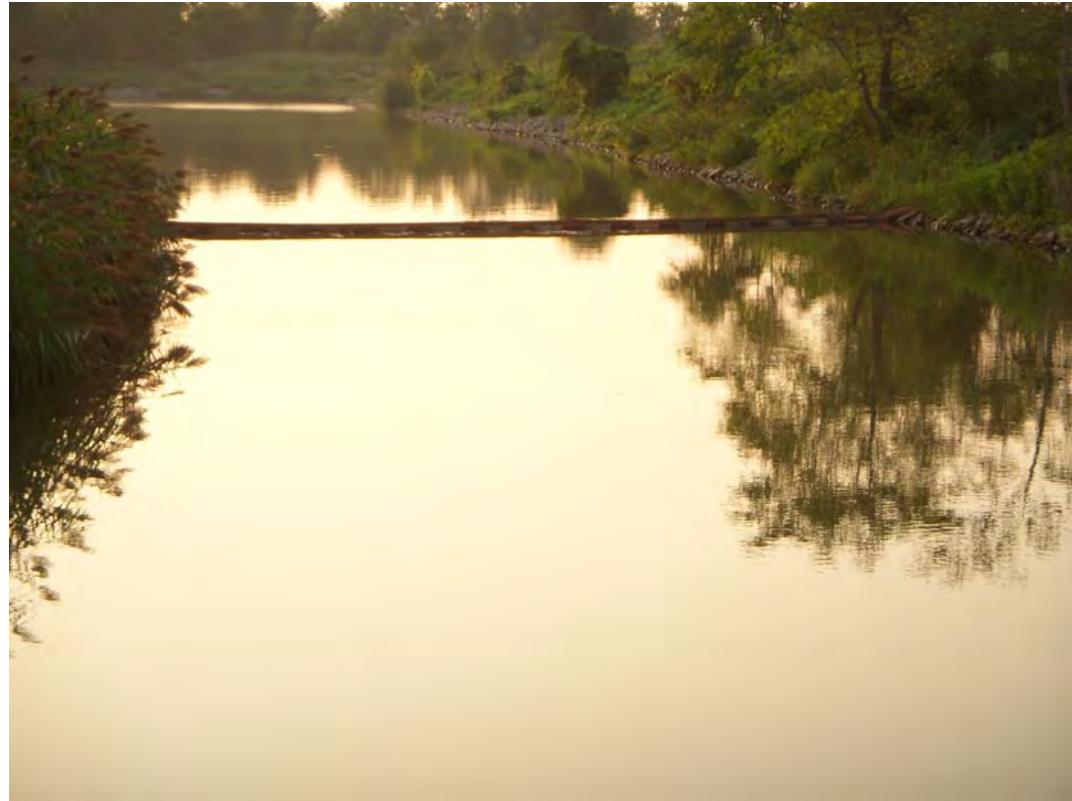
Photo Number:  
1

Description:  
Floating  
skimmer on  
Primary Pond  
outlet channel  
(inlet to Ash  
Pond A)

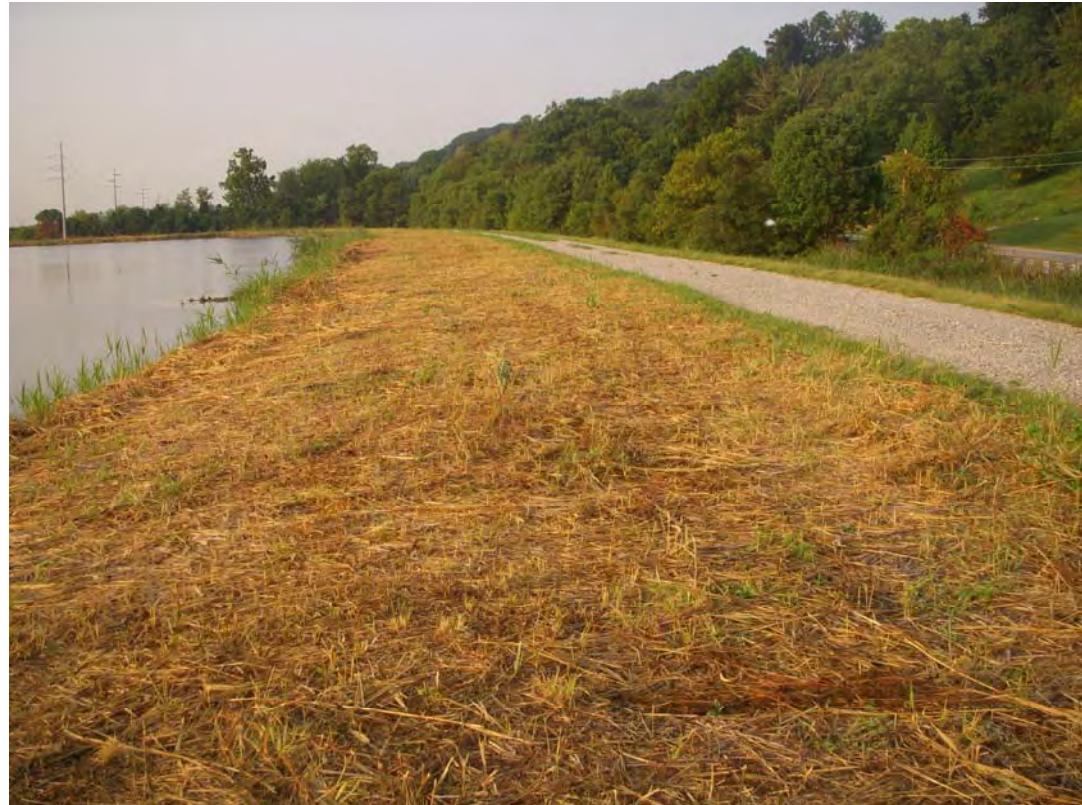
Photo Number:  
2

Description:  
Inboard side of  
western  
embankment of  
Ash Pond A

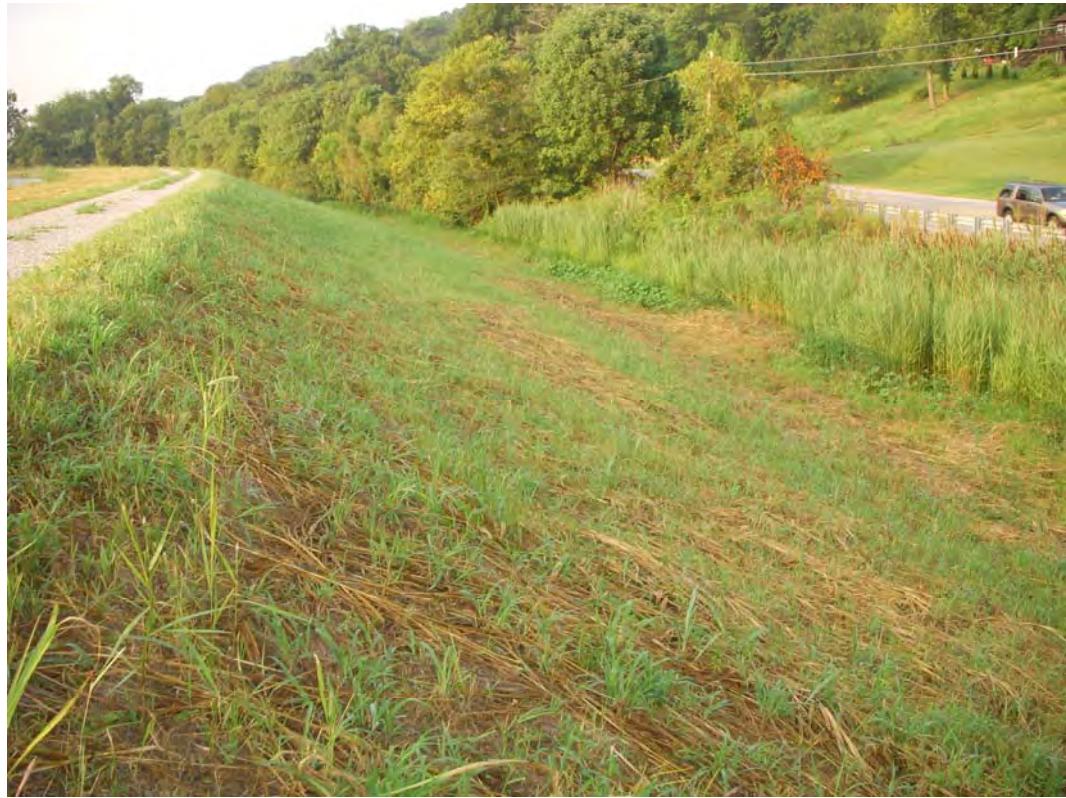
Date:  
8/13/10Photo Number:  
3Photographer:  
Tim Kraus

Orientation:  
Looking SouthDescription:  
Outboard slope  
of western  
embankment of  
Ash Pond A

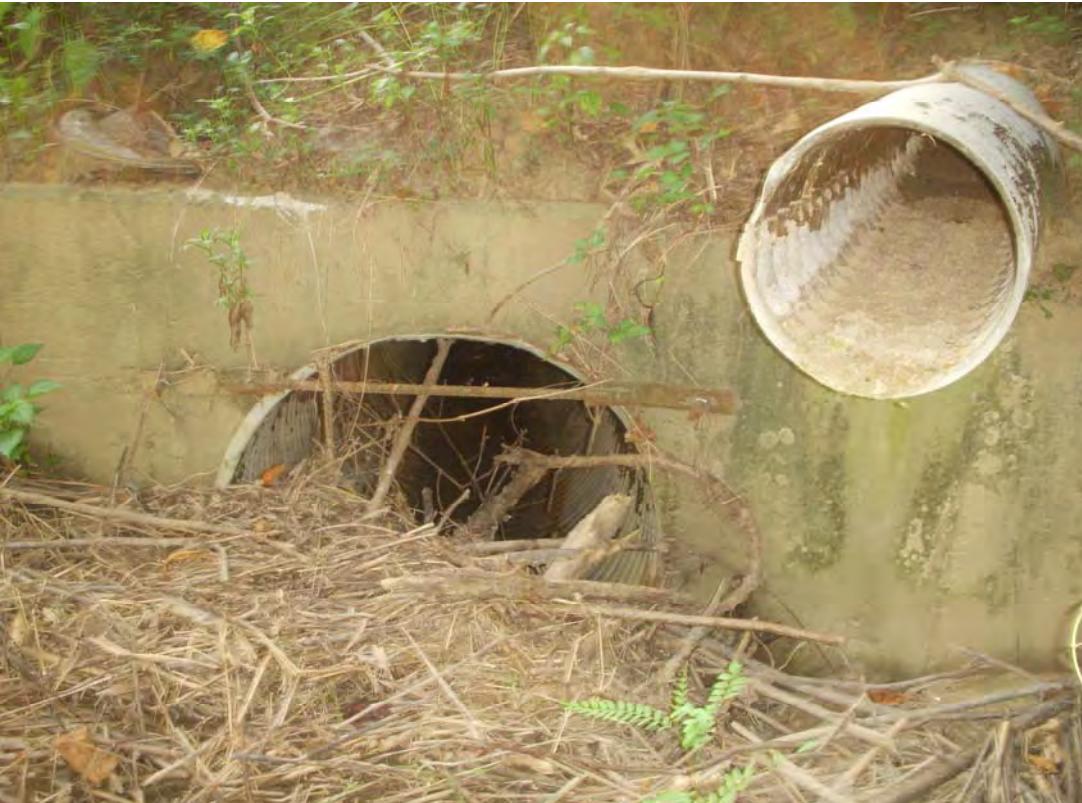
Date:  
8/13/10Photo Number:  
4Photographer:  
Tim Kraus

Description:  
Outlet pipe for  
the drainage  
channel at the  
southwestern  
corner of Ash  
Pond A

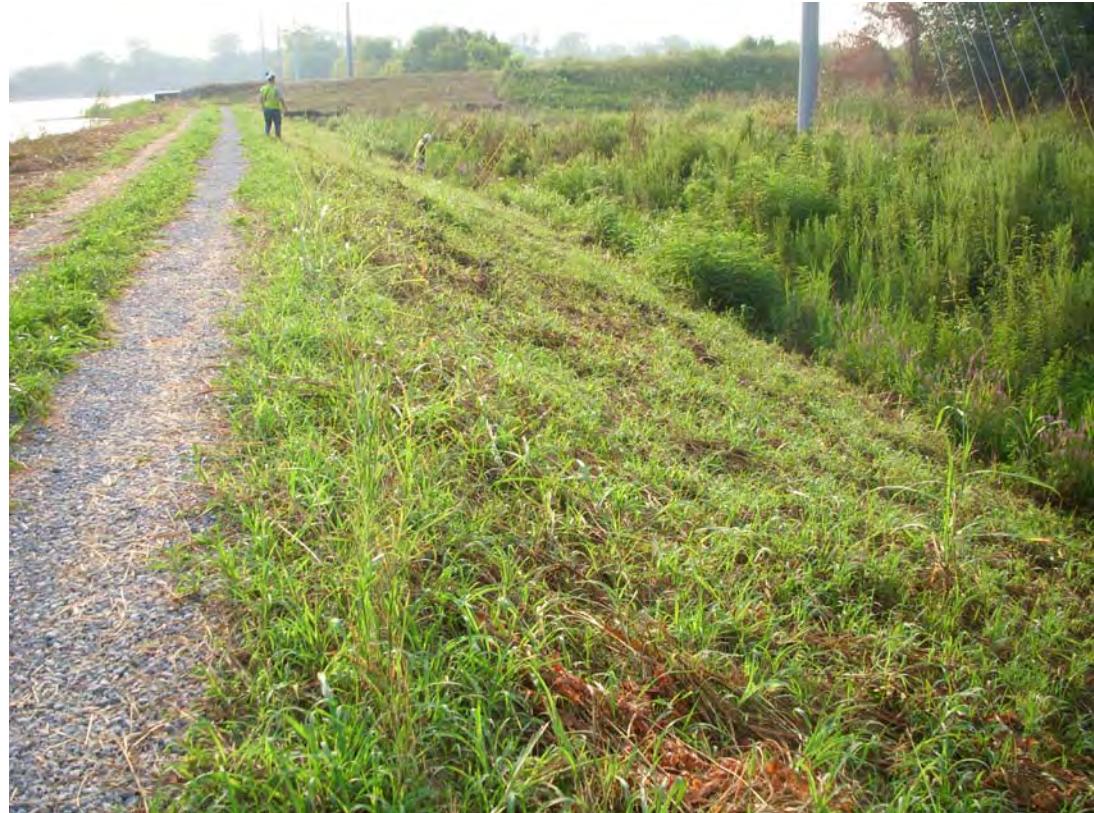
Orientation:  
Looking EastDescription:  
Southern  
embankment of  
Ash Pond A

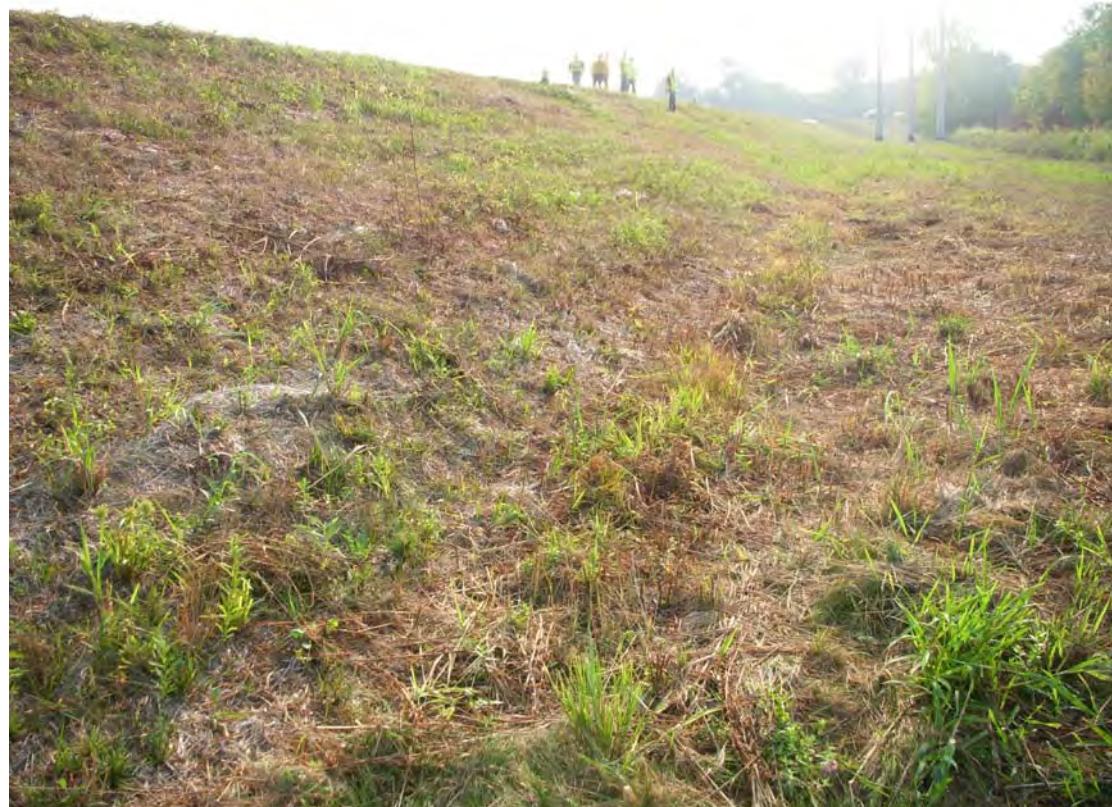
Date:  
8/13/10Photo Number:  
6Photographer:  
Tim Kraus

- The outboard slope of the southern embankment ties into an abandoned road embankment (Old River Road). For the purposes of this report, the tie-in point is considered to be the outboard toe of the embankment; however, it should be noted that the abandoned road embankment slopes down to a lower elevation beyond the Ash Pond A embankment (Appendix B – Photos 6 and 7).

Date:  
8/13/10Photo Number:  
5Photographer:  
Tim KrausOrientation:  
Looking EastDescription:  
Outboard  
slope of  
southern  
embankment of  
Ash Pond A

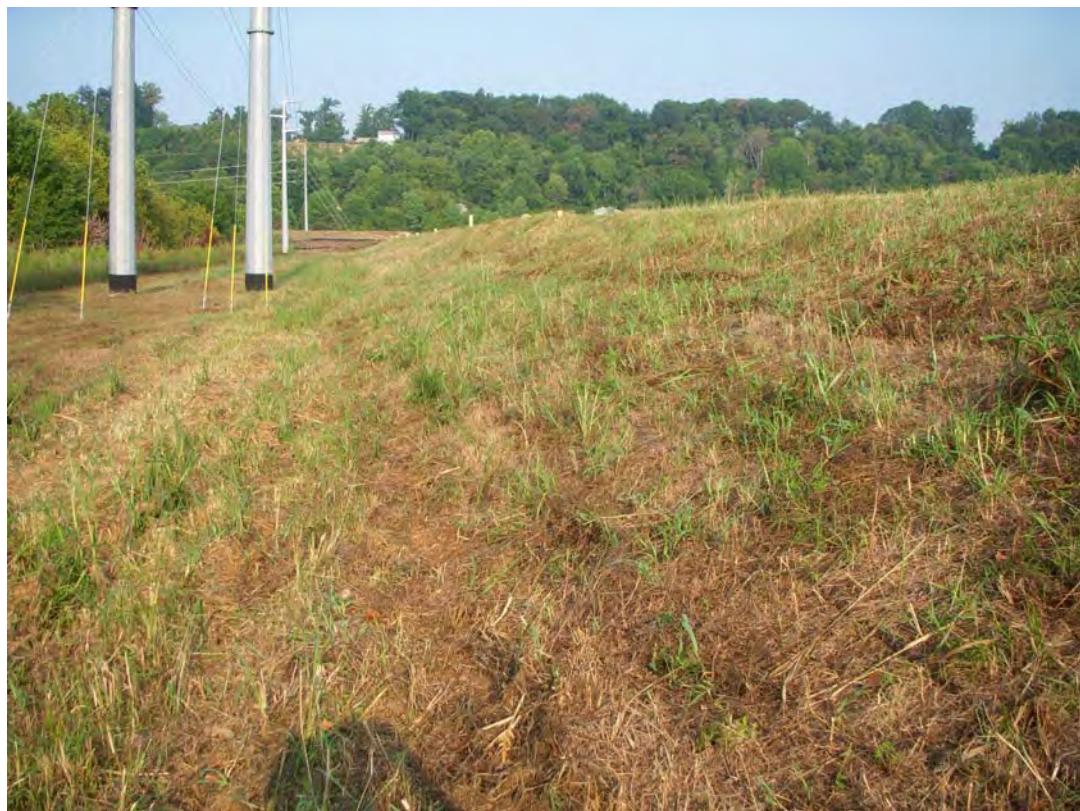
Photo Number:  
7

Description:  
Outboard  
slope of  
southern  
embankment of  
Ash Pond A

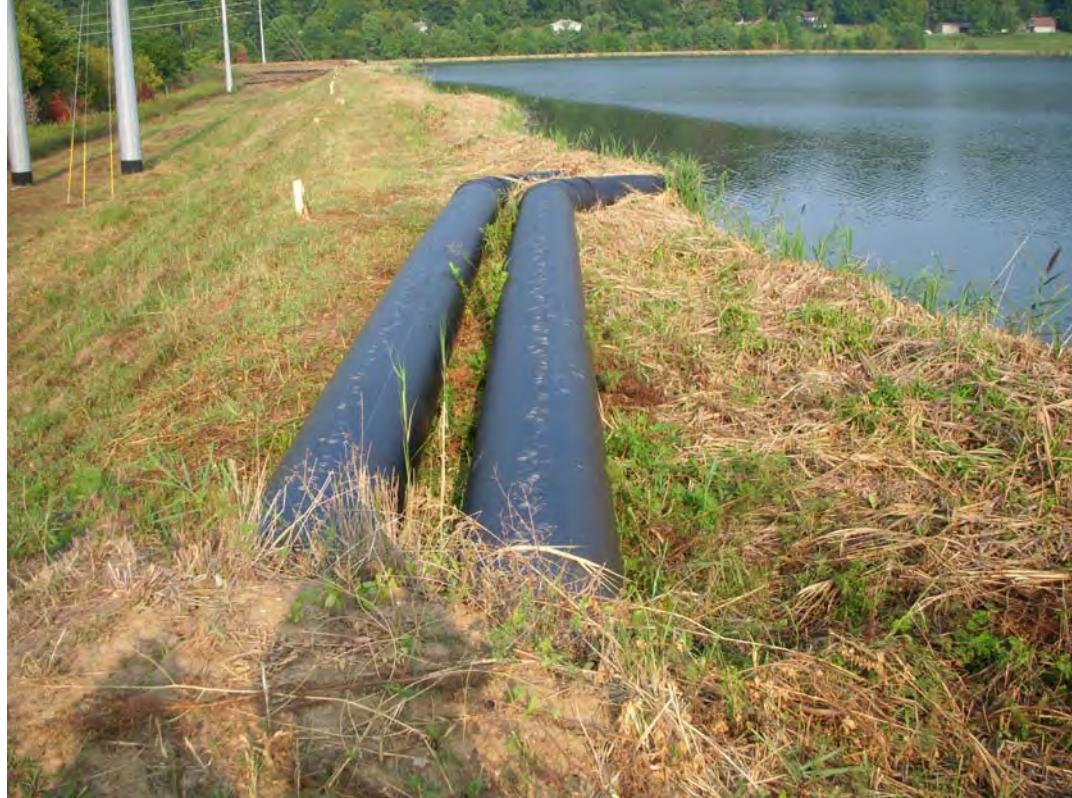
Photo Number:  
8

Description:  
Landfill storm  
water and  
leachate  
effluent pipes  
into Ash Pond A

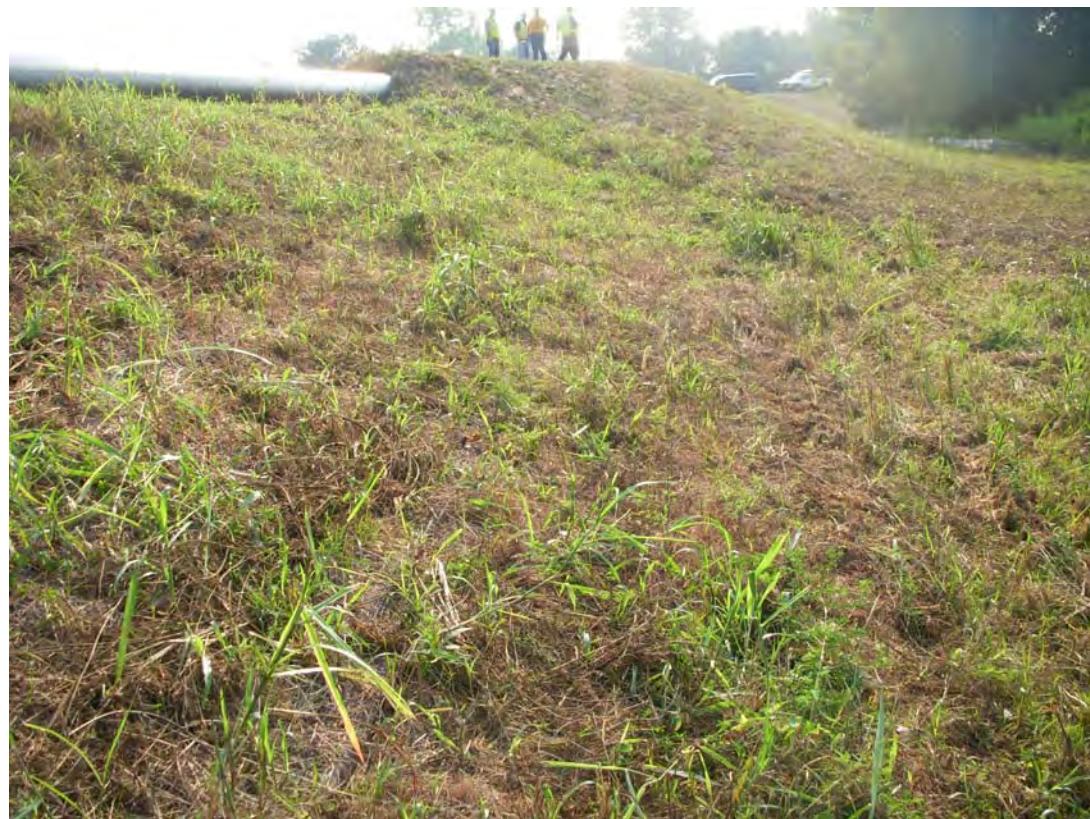
Date:  
8/13/10Photo Number:  
9Photographer:  
Tim Kraus

Orientation:  
Looking EastDescription:  
Raised section  
of southern  
embankment of  
Ash Pond A for  
landfill pipe  
cover

- Based on the hydrologic/hydraulic analyses recommended above, a design crest elevation should be established for the embankments and low spots in the crest should be filled/raised to create a uniform crest elevation around Ash Pond A (except in the area of the landfill leachate/drain pipes).

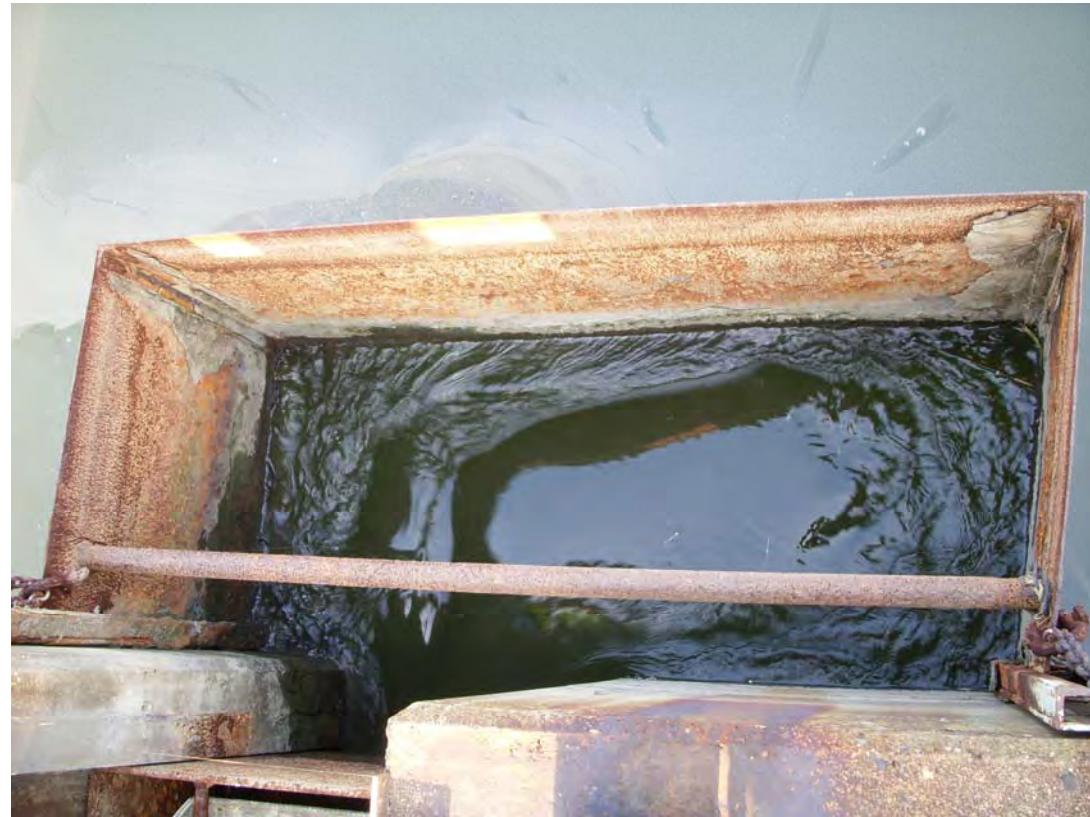
Date:  
8/13/10Photo Number:  
10Photographer:  
Tim Kraus

- Weir boxes (rather than trash racks) have been installed to prevent floating debris from entering both the principal and emergency spillways (Appendix B – Photos 10 and 11). The principal spillway appears to be in good condition and functioning as designed, with flow occurring into the Secondary Pond on the date of the inspection. Stop logs are used to adjust the overflow elevation of the principal spillway, as necessary.

Description:  
Weir box for  
principal  
spillway inlet at  
southeastern  
corner of Ash  
Pond A

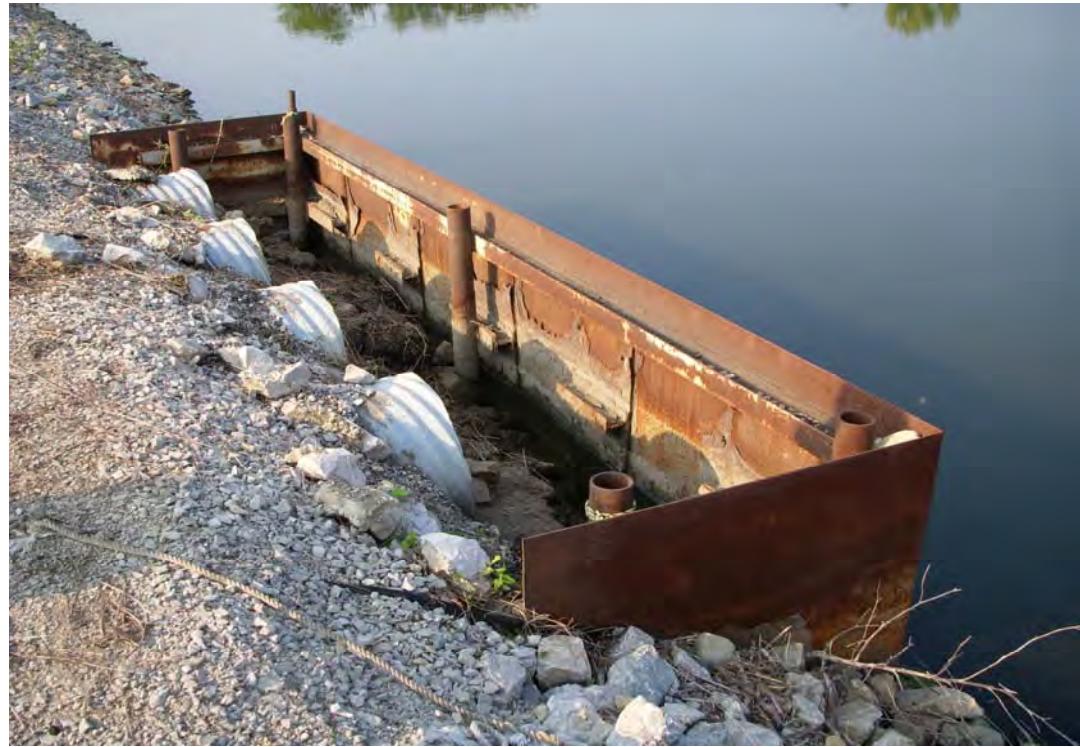
Photo Number:  
11

Description:  
Weir box for  
emergency  
spillway outlet  
pipes from Ash  
Pond A to the  
Secondary Pond

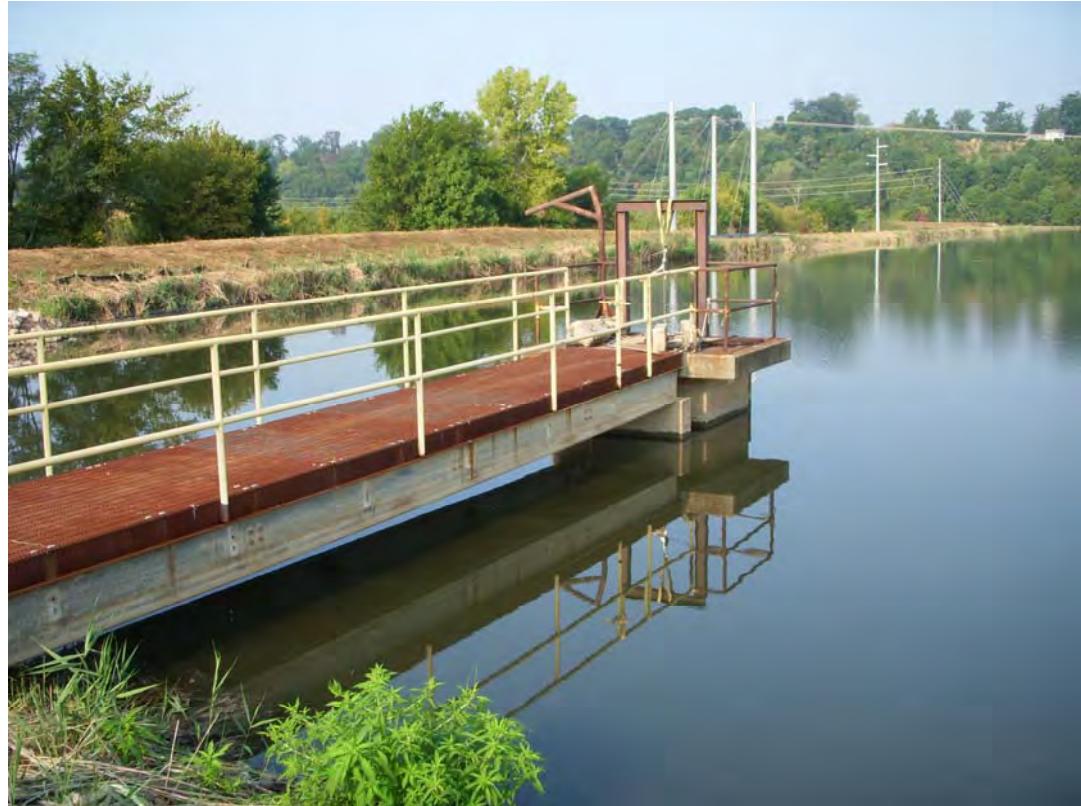
Photo Number:  
12

Description:  
Access bridge  
and operating  
platform for  
Ash Pond A  
principal  
spillway

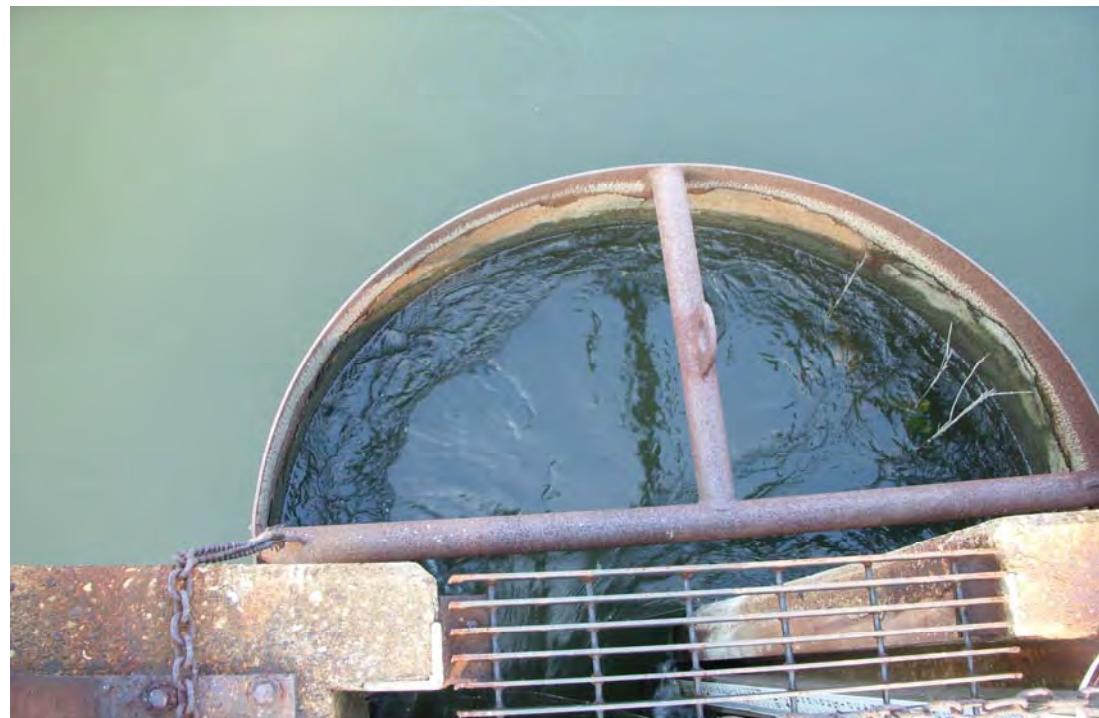
Photo Number:  
3

Description:  
Principal  
spillway inlet  
for the  
Secondary Pond

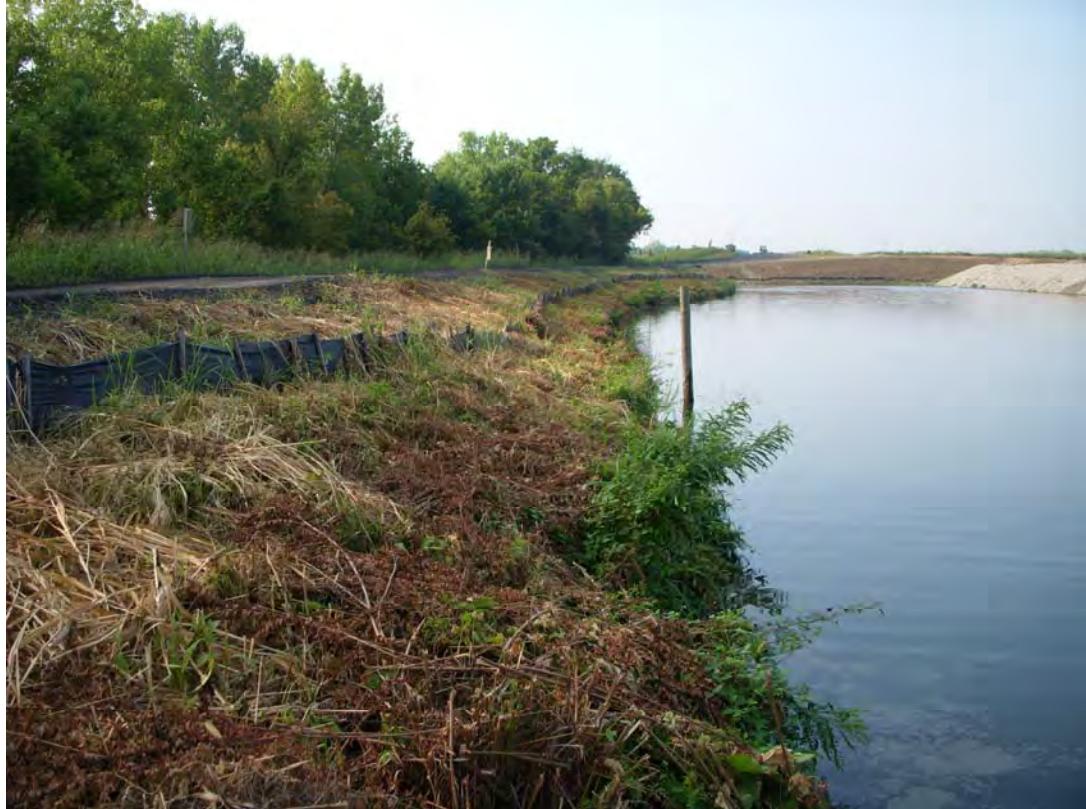
Photo Number:  
4

Description:  
Inboard slope  
of the eastern  
embankment of  
the Secondary  
Pond

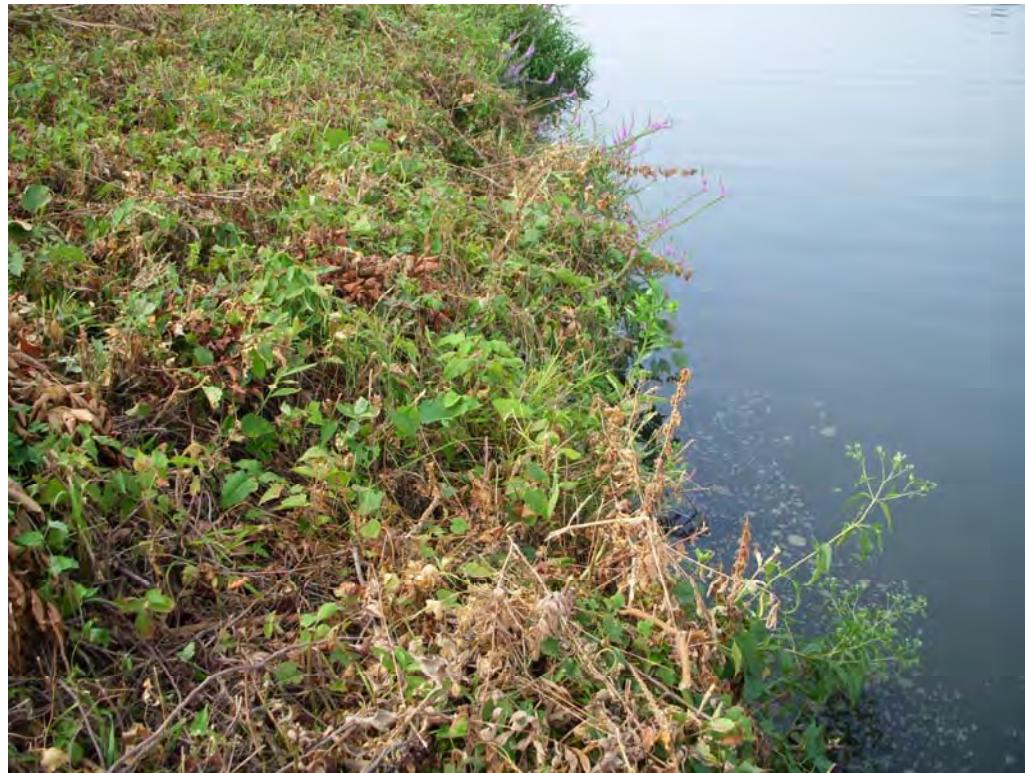
Date:  
8/13/10Photo Number:  
5Photographer:  
Tim Kraus

Orientation:  
Looking SouthDescription:  
Cut vegetation  
along the  
inboard slope  
of the eastern  
embankment of  
the Secondary  
Pond

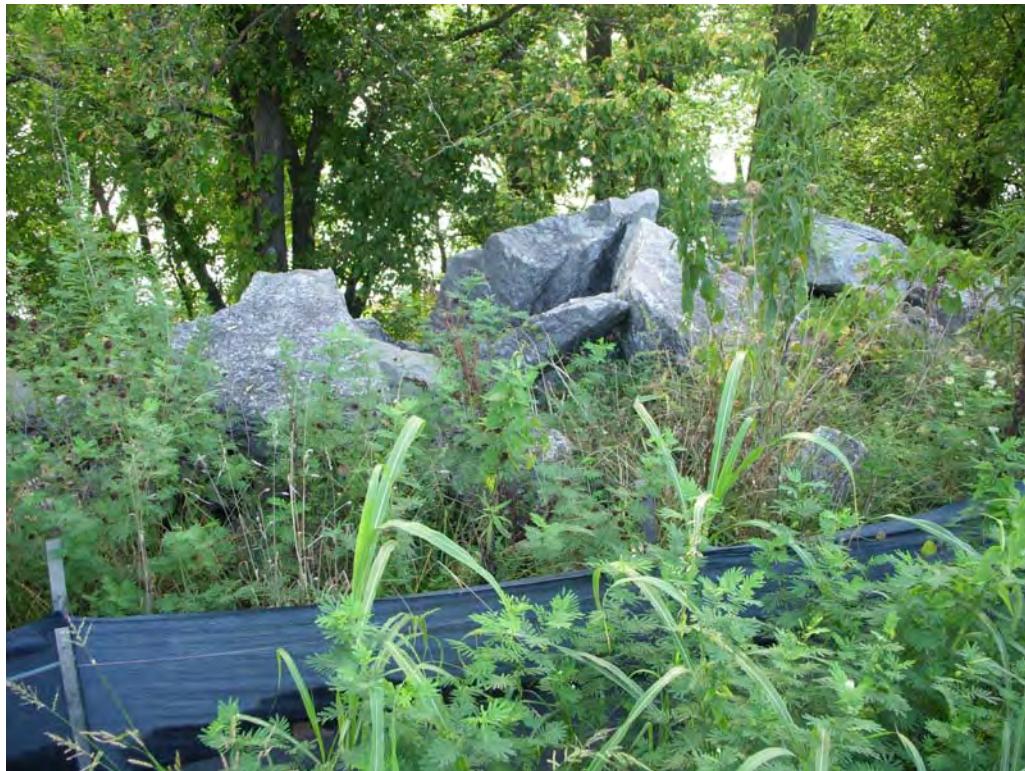
Date:  
8/13/10Photo Number:  
6Photographer:  
Tim Kraus

Large riprap and  
overgrowth of  
trees on  
outboard slope  
of eastern  
embankment  
(Ohio River  
bank) of  
Secondary Pond

- Standard dam safety practice typically recommends the removal of trees from earth embankment sections, due to the potential for uprooting of the trees during storm events and the resulting damage to the embankment. However, since the outboard slope of the eastern embankment also serves as the Ohio River bank, the large trees growing on the slope may reduce the erosion potential from high river flows and, therefore, we recommend that these trees be left in place. However, it would be advisable to perform periodic inspections of this slope, particularly after major storm events, to identify any trees that may have been uprooted and damaged the embankment.

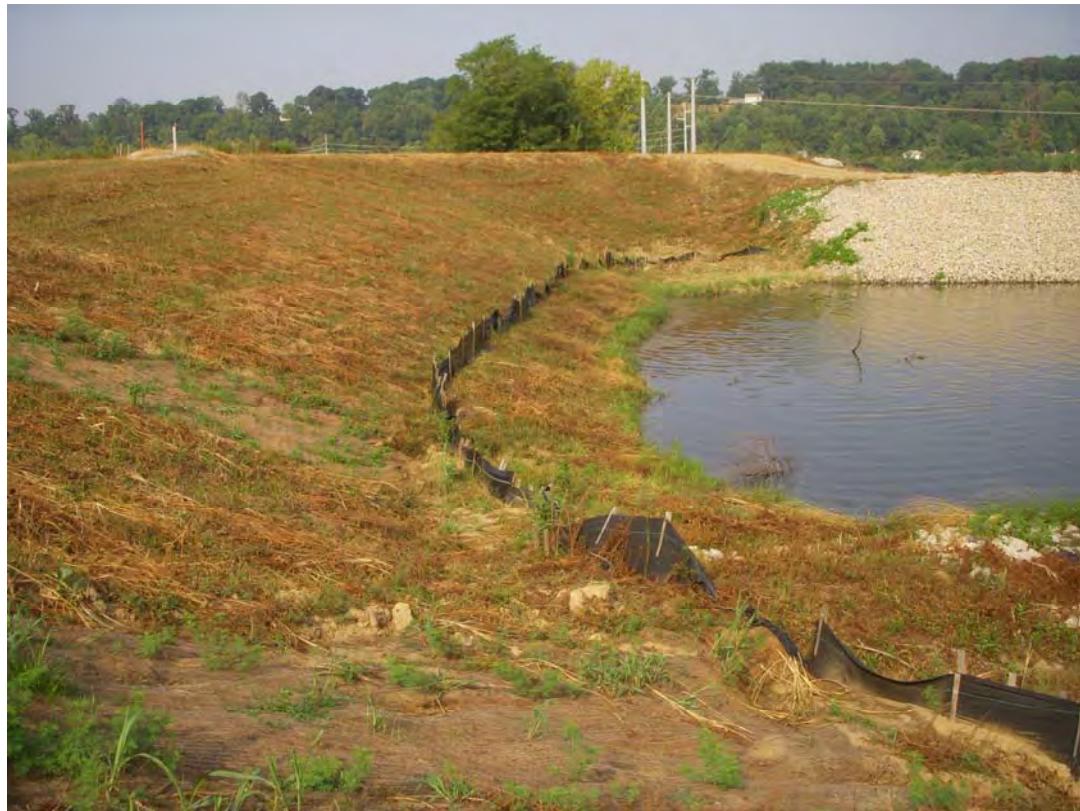
Photo Number:  
7

Description:  
Tie-in of  
separation dike  
and eastern  
embankment  
at south end of  
the Secondary  
Pond

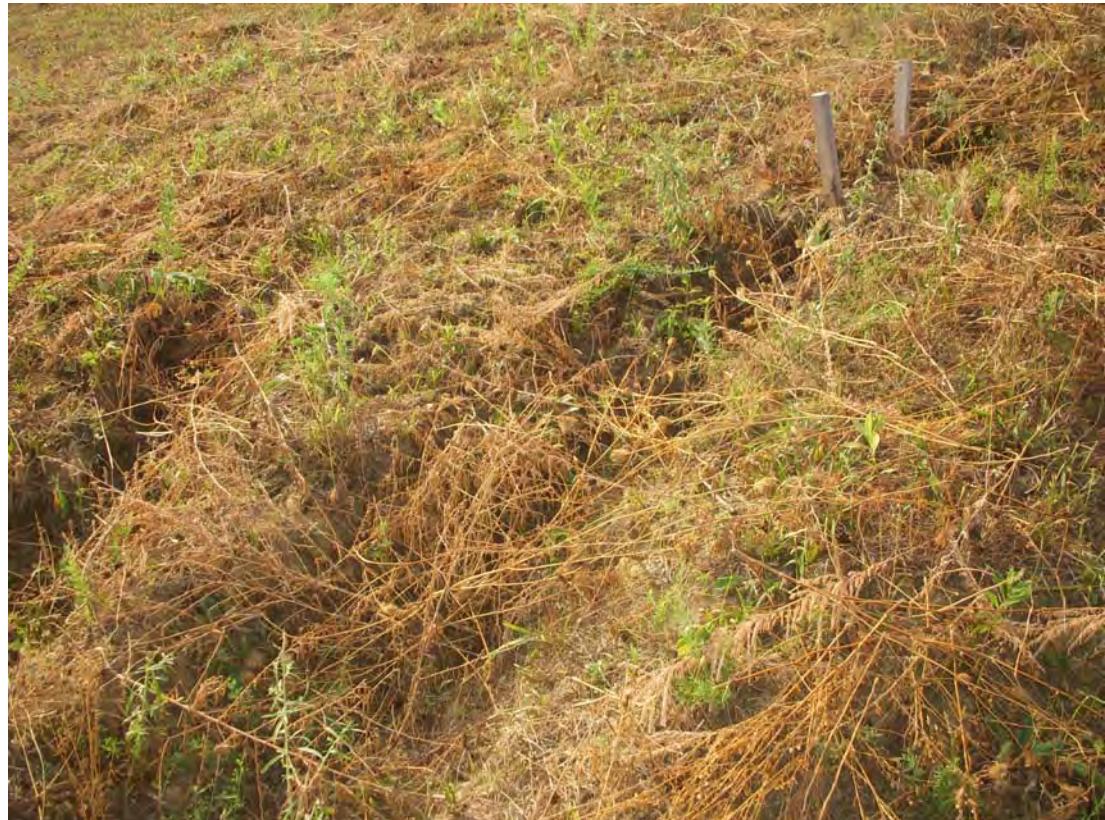
Photo Number:  
8

Description:  
Runoff erosion  
rills along the  
slope at the  
south end of  
the Secondary  
Pond
